# Manhole Inspection Summary

Manhole # S45MM\_022MH

**Inspection** ☐ Is Incomplete Rating: **3) Fair**

Insp Date: **3/25/08 8:42 AM**

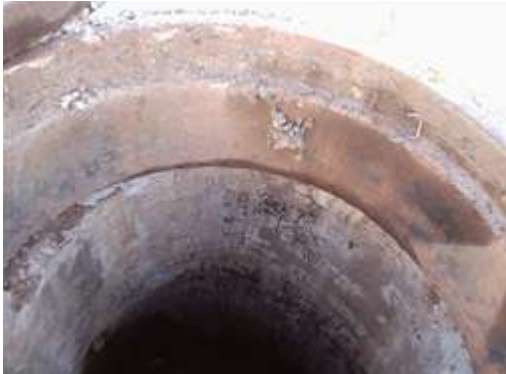
Defect 2

☒ **Leaks**

Frame Leaks

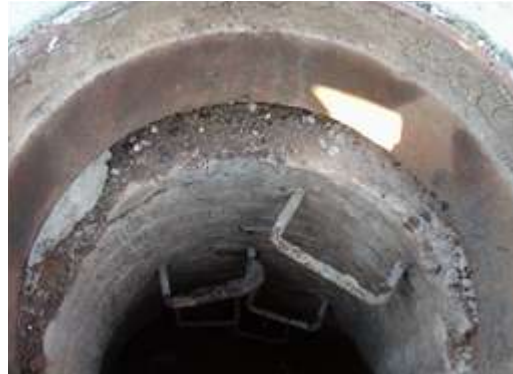
Defect 1

**Frame** Offset: **3** (in.)

Offset

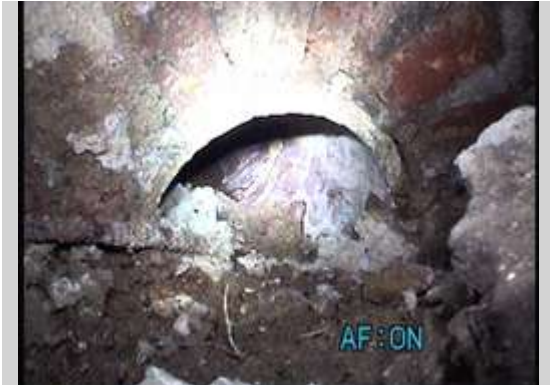
12 O'Clock Outflow

8 in. Circular Gravity Sewer  
Pipe Out @ 12 O'Clock

Deposits: ☐ None ☒ **Mud** ☐ Sludge ☒ **Debris** ☐ Grease

Silt Depth: **5** (in.) Deposits Extent: **Heavy**
